Town of Hyde Park Road Erosion Inventory Report

Lamoille County Planning Commission

December 2017

Inventory and report funded by the Vermont Agency of Transportation 2016 Better Roads Program

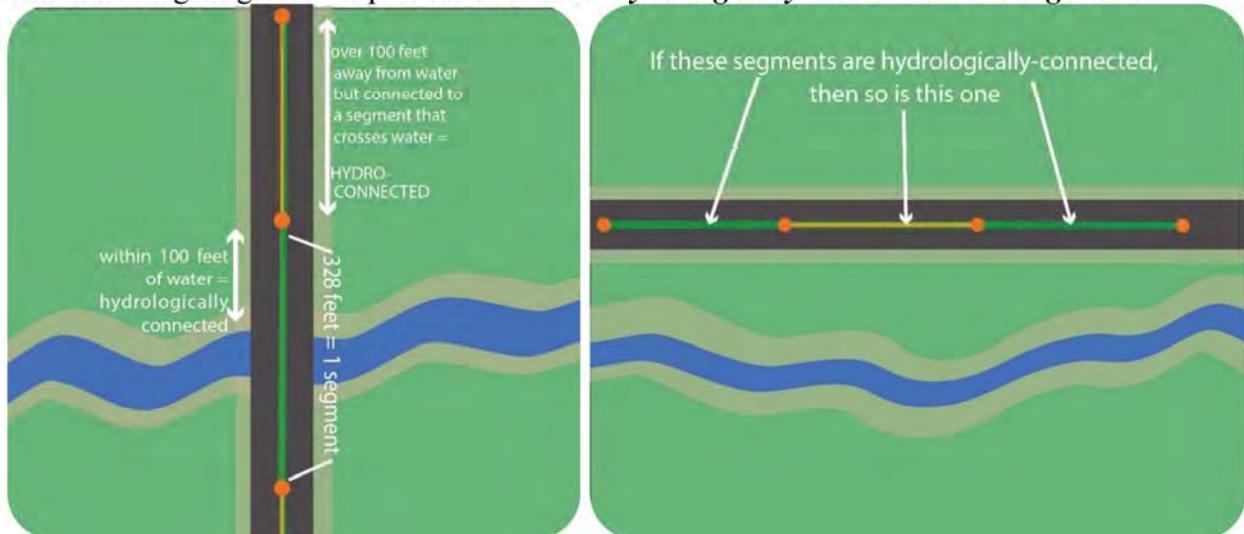
Hydrologically-connected road segments are indicated by one or more of the following:

- Within 100 feet to water resources (perennial and intermittent streams, wetlands, lakes and ponds)
- Road segments that bisect a water resource
- Adjacent segments to connected segments
- Catch basin outfall pipe is 500 feet or less from a water of the state

The following diagrams* depict the criteria for *hydrologically-connected road segment*:

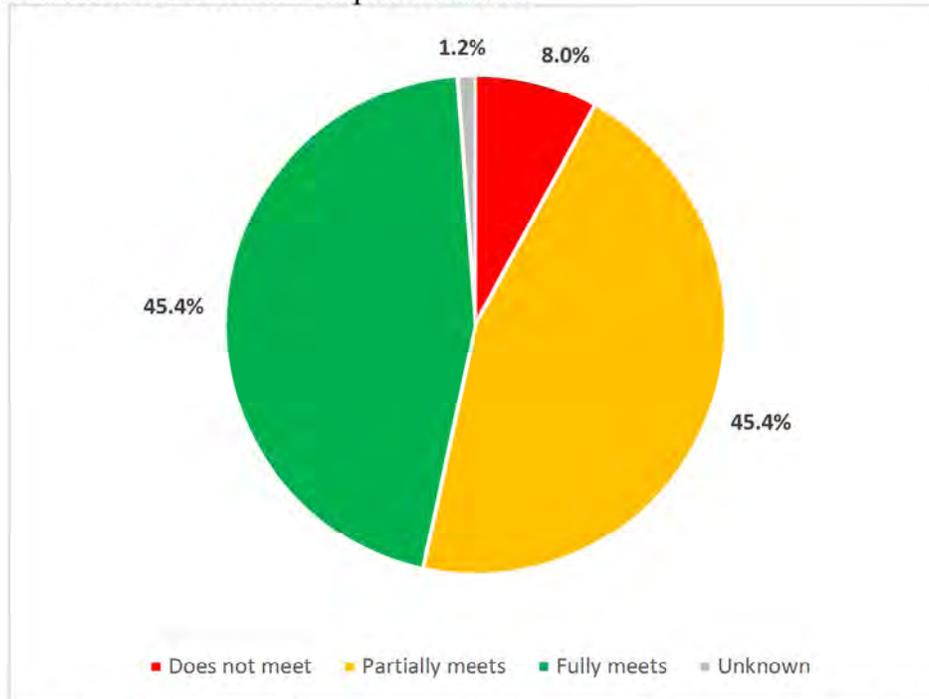
This pie-chart summarizes MRGP compliance status:

- There are 339 hydrologically-connected road segments in Hyde Park, or 21.1 miles (including class 4 roads)
- Of these, 55% (185 segments) do not fully meet standards; which equals approximately 11.5 miles of road

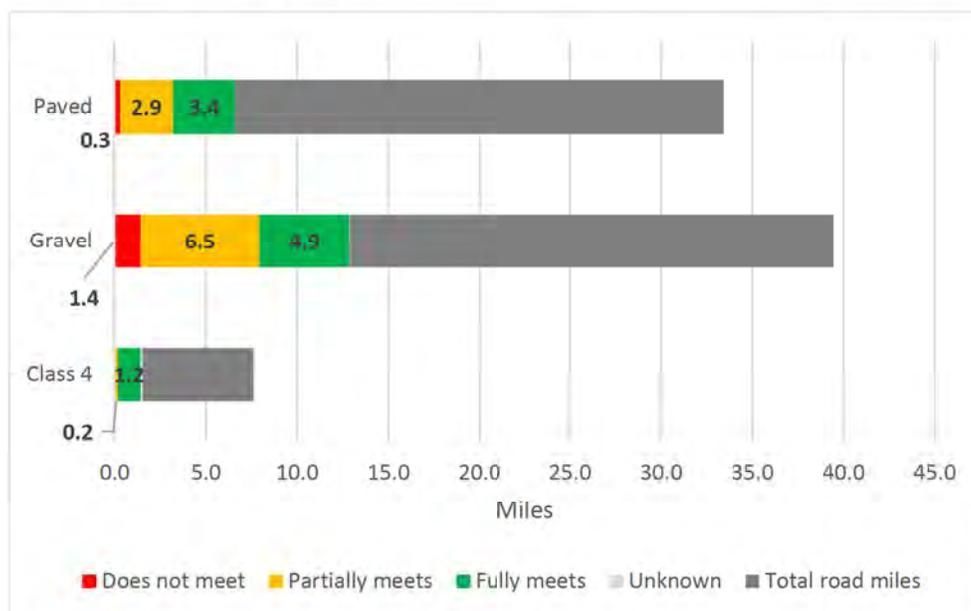
The following bar chart depicts the scoring breakdown (fully meets, partially meets, does not meet) by road type for hydrologically-connected road miles within the town's total road miles.

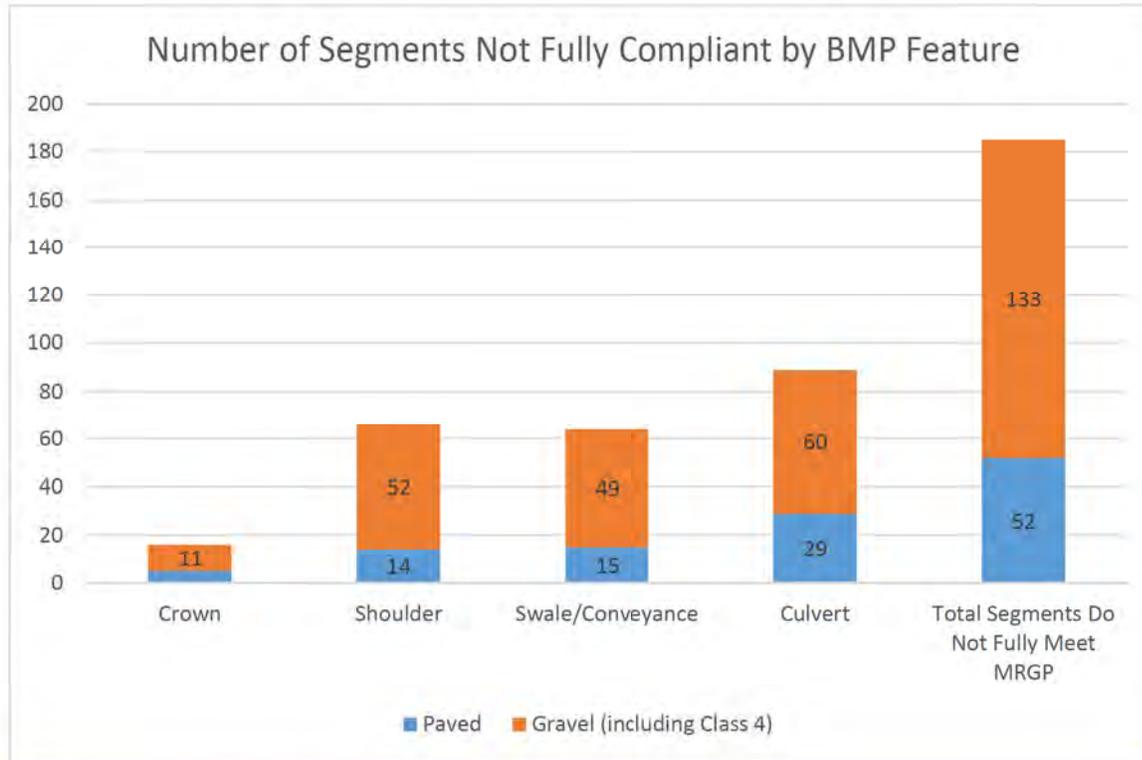
The following graph depicts the number of segments *not* in full compliance with the MRGP, by BMP categories (crown, shoulder, swale & conveyances, culverts). Some non-compliant segments have more than one BMP category in need of improvement, therefore the sum of the BMP features exceeds the total count of segments not fully meeting MRGP standards.

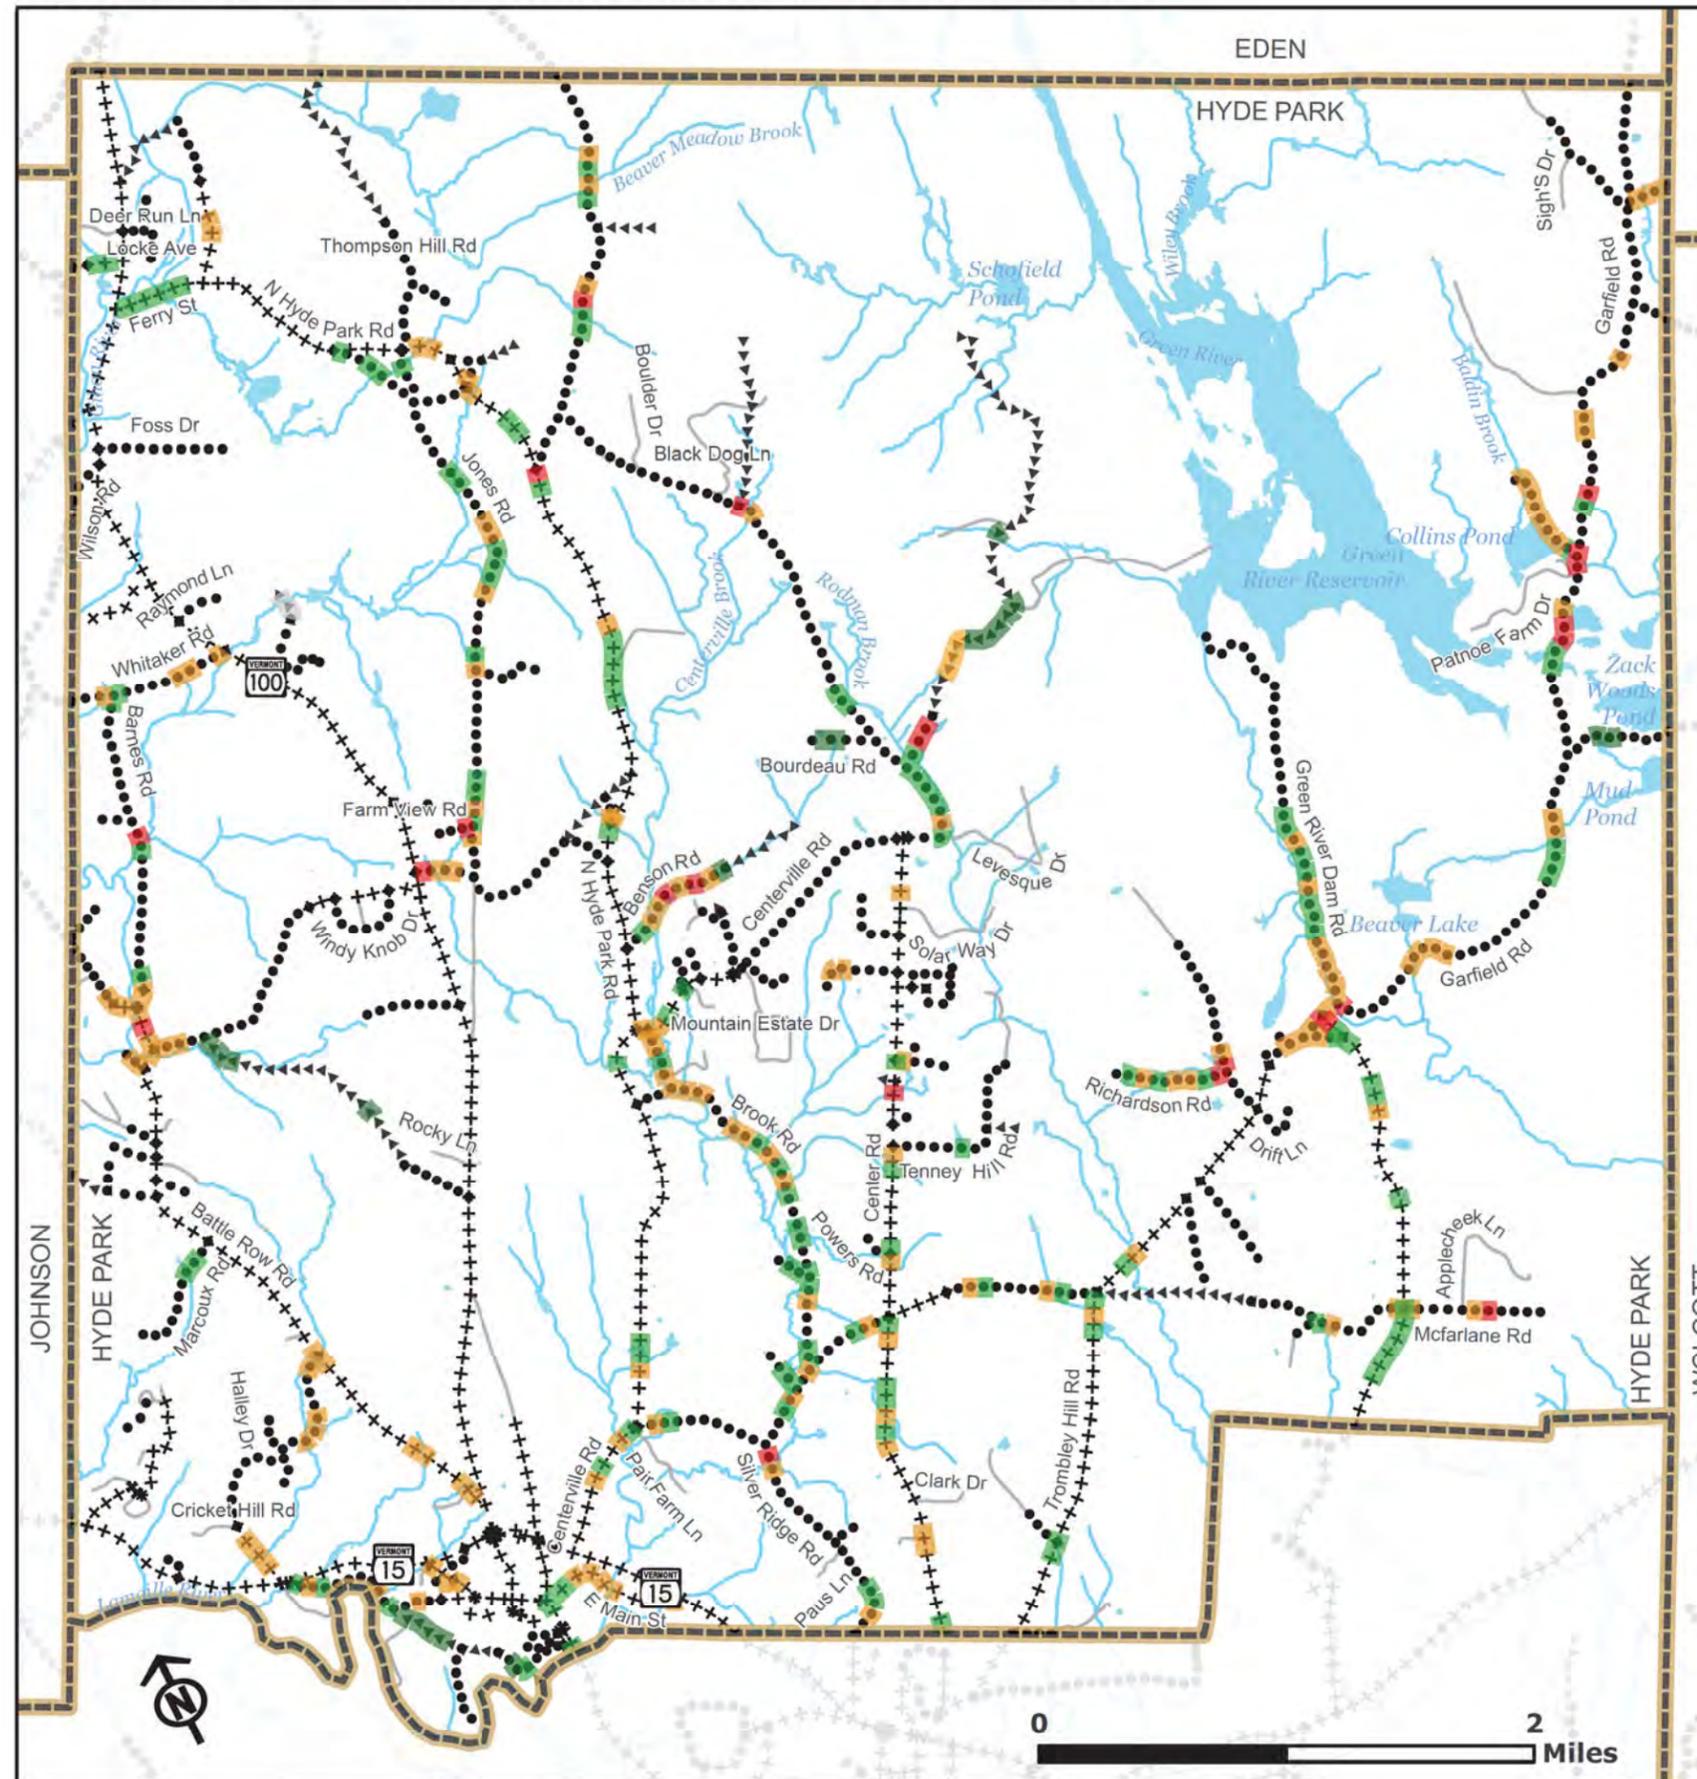
Hyde Park Road Erosion Inventory 2016-17: DRAFT

Municipal roads General Permit Score

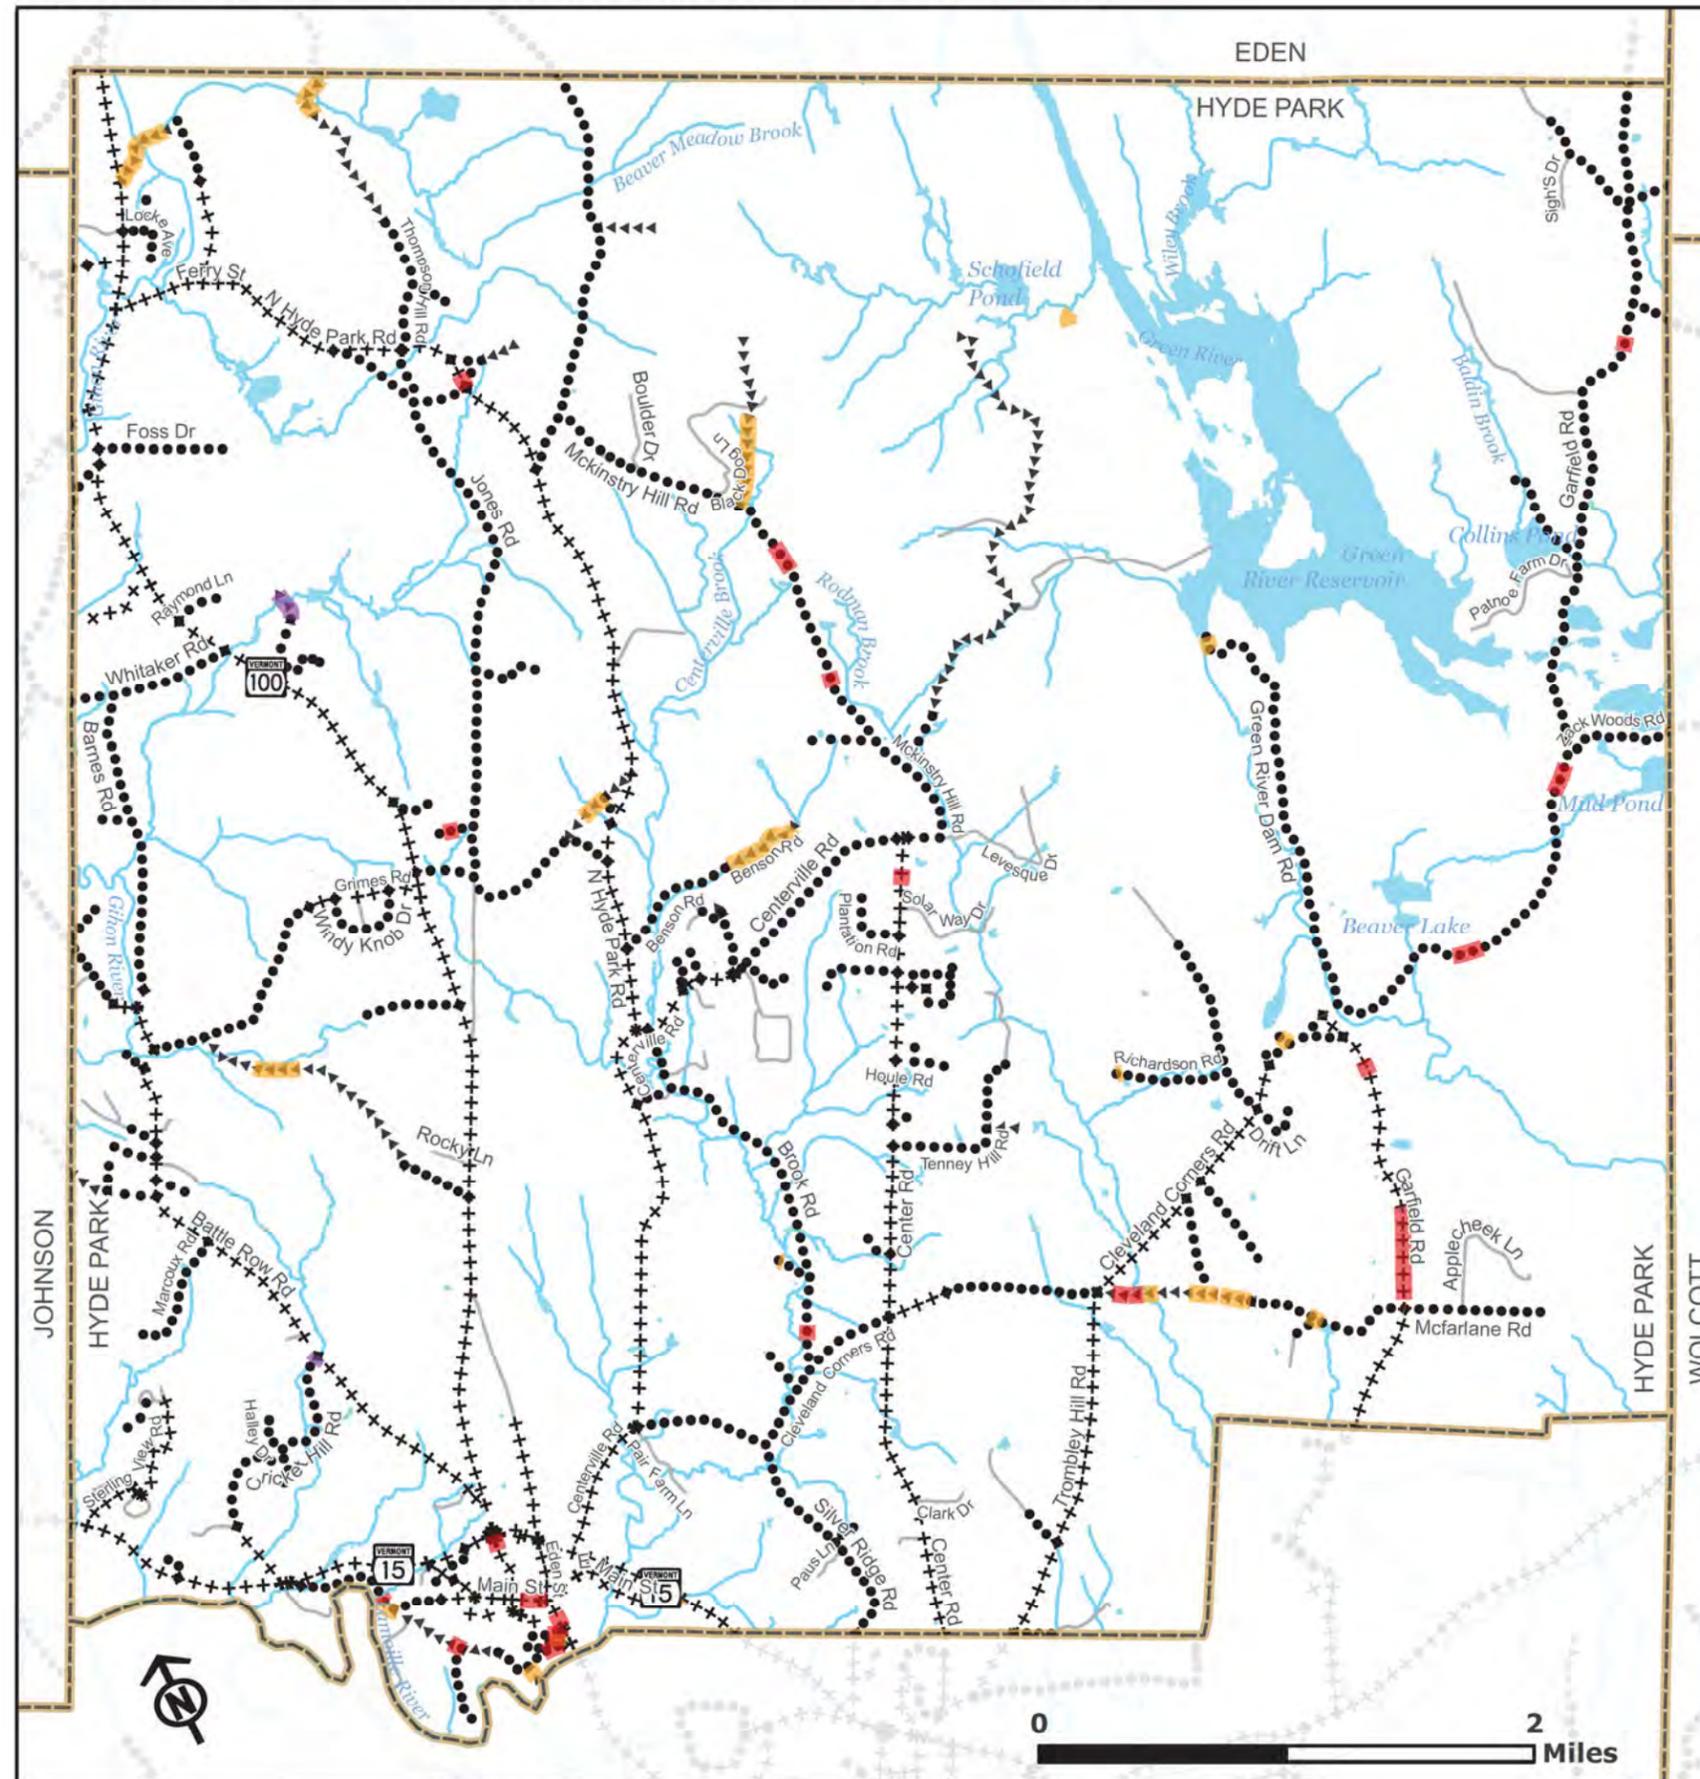
Hyde Park Road Erosion Inventory 2016-17: Draft

Potential Error Source

- May not be connected
- May not be a road or not a good segment
- Missing or incomplete field data

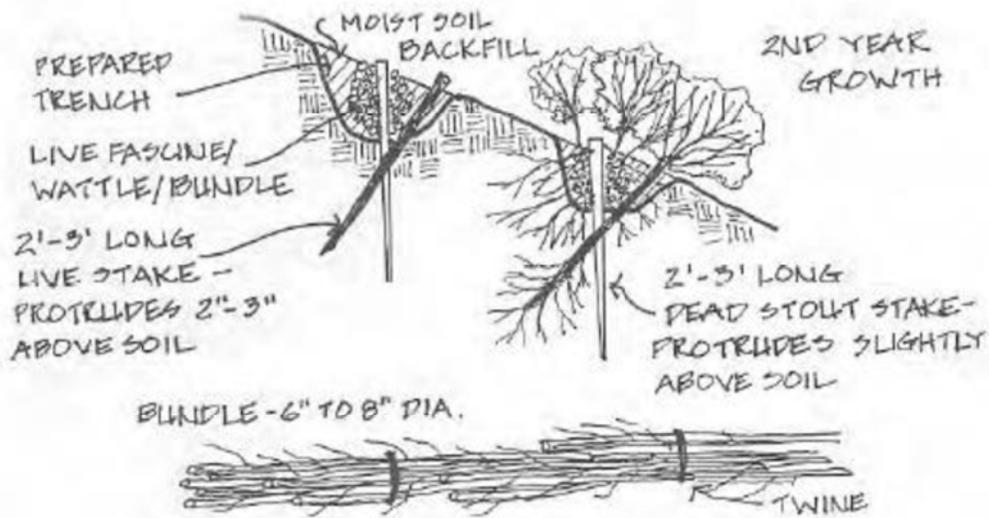
LIVE FASCINES/WATTLES/BUNDLES

(BBR Manual – pg. 35)

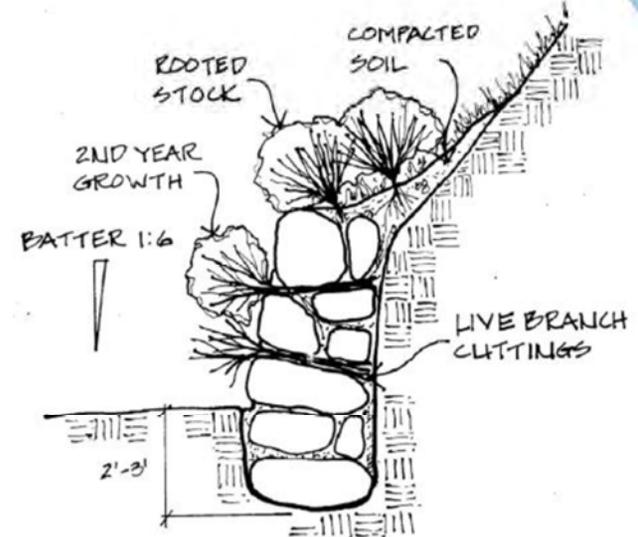
VEGETATED ROCK WALL
 (BBR Manual – pg. 44)

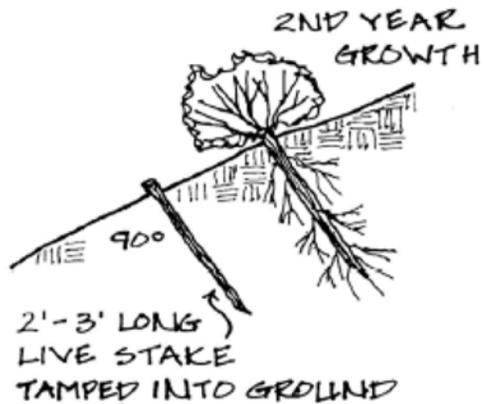
LIVE STAKES

(BBR Manual – pg. 36)

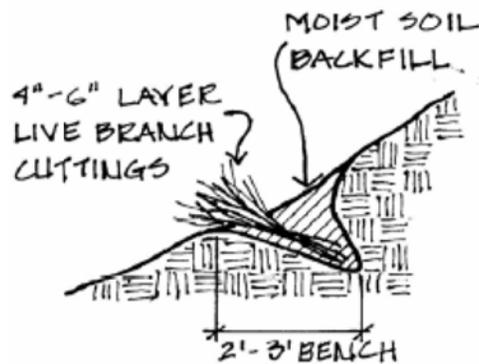
BRUSHLAYERING

(BBR Manual – pg. 36)

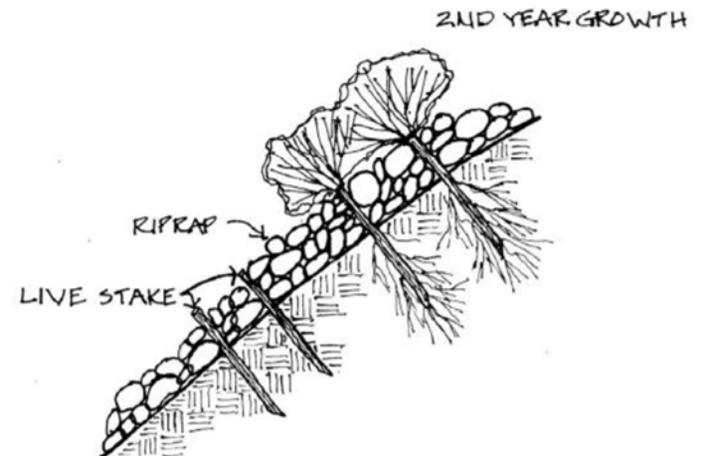
VEGETATED RIPRAP

(BBR Manual – pg. 45)

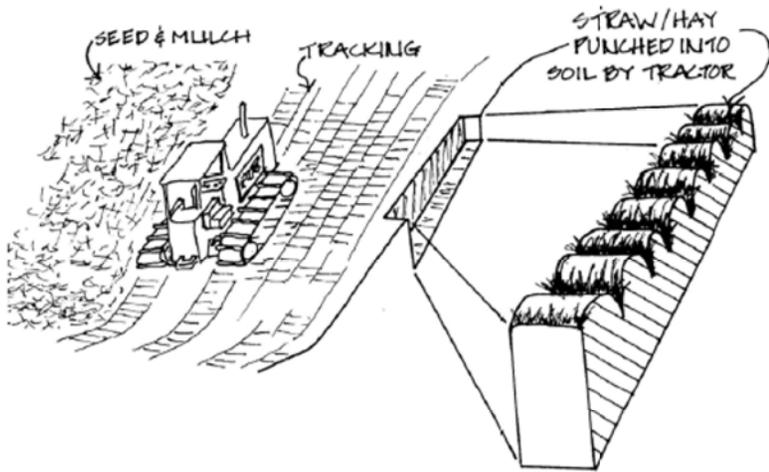
SURFACE ROUGHENING
 (BBR Manual – pg. 34)

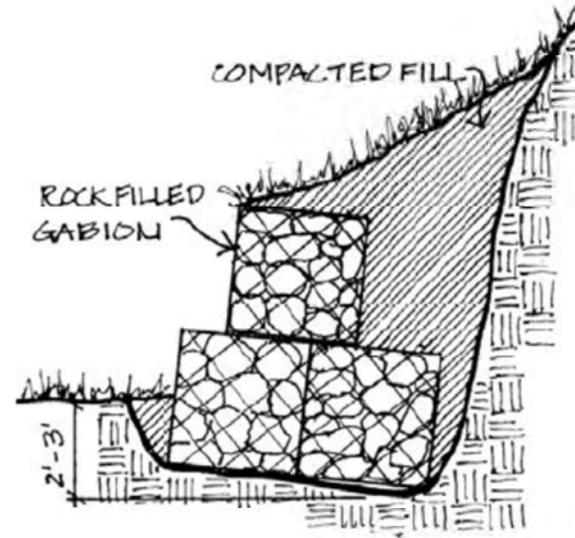
GABION WALL
 (BBR Manual – pg. 39)

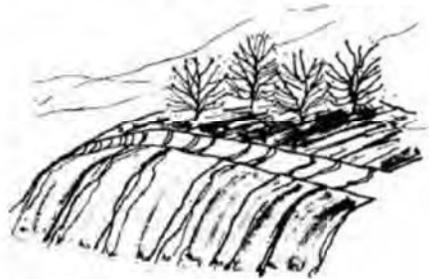
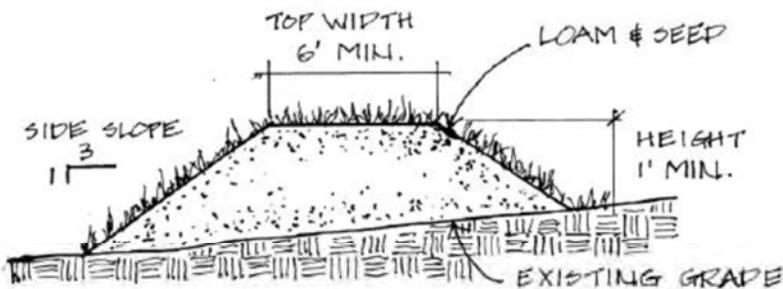
DIVERSION BERM
 (BBR Manual – pg. 15)

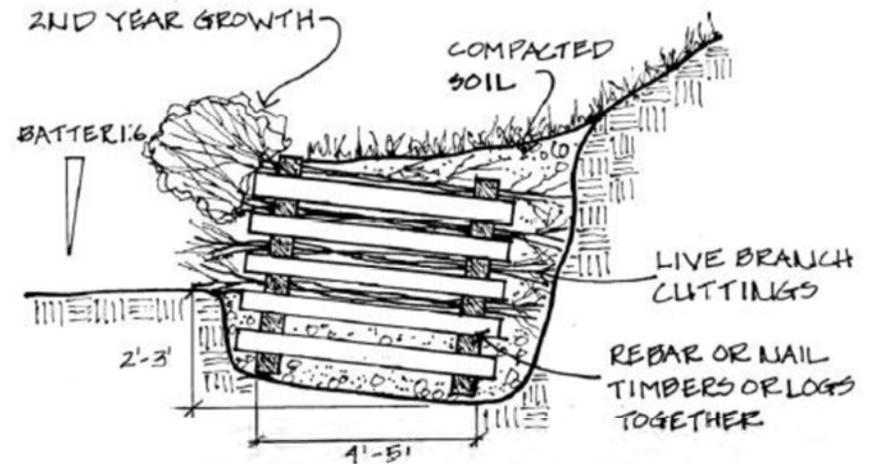
LIVE CRIBWALL
 (BBR Manual – pg. 42)

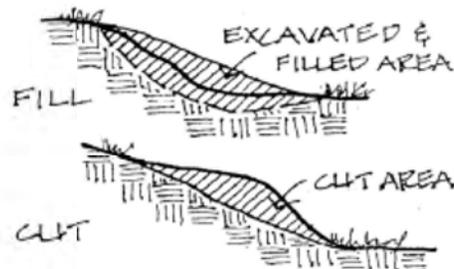
Cut and/or Fill:

The removal or addition of soil to the bank to create the desired 2:1 or flatter slope, often times removing less stable soils and replacing them in the process of regrading the slope.

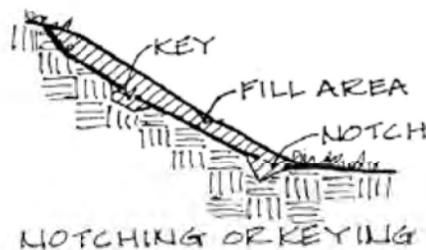
(BBR Manual – pg. 38)

Notching or Keying:

A "V" or trapezoid shaped cut made in the existing ground to help further stabilize the slope.

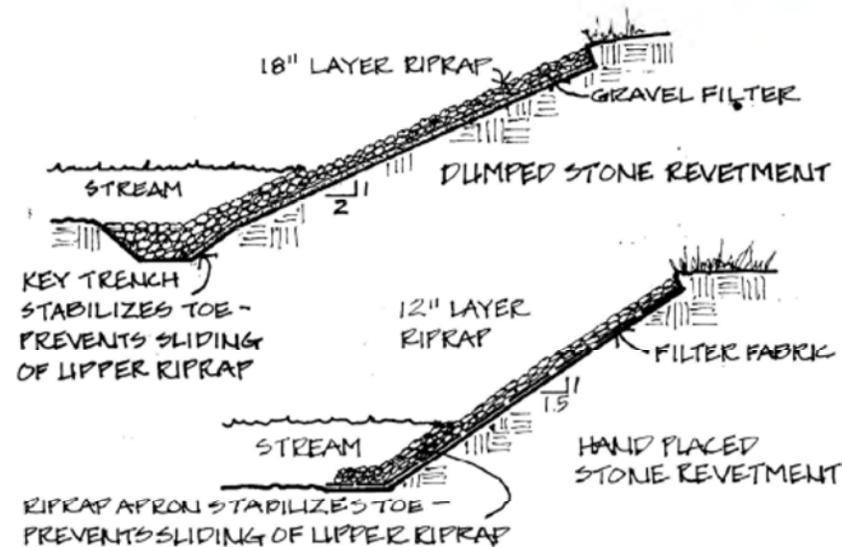
RIPRAP REVETMENT
(BBR Manual – pg. 41)

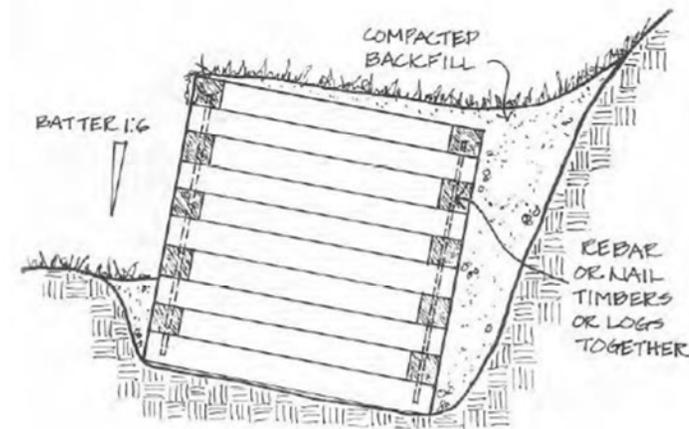
LOG OR TIMBER CRIB
(BBR Manual – pg. 40)

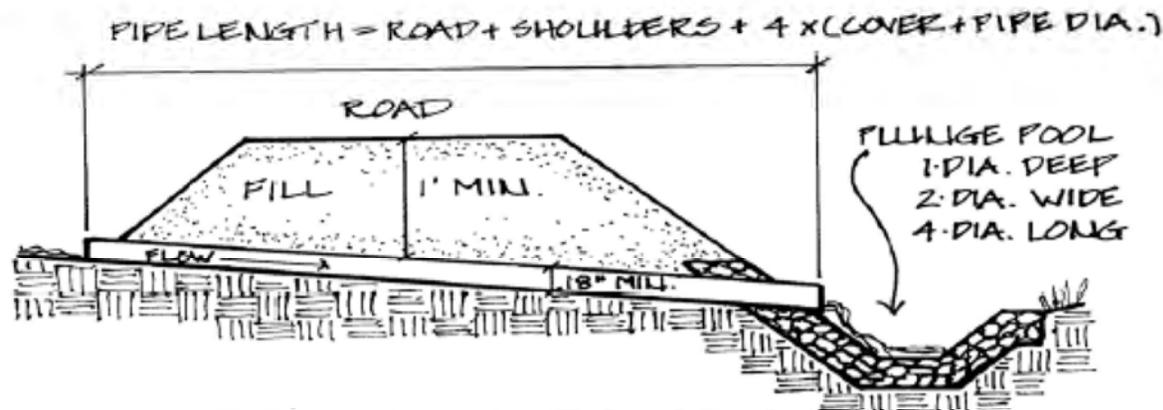
Culvert length example calculation:
 Using 18 inch (1.5 ft.) culvert with 1.5 ft. of cover and 28 ft. road + shoulder width.
 Step 1: Pipe length = 28 + 4 (1.5 + 1.5) Step 2: Pipe length = 28 + 4 (3)
 Step 3: Pipe length = 28 + 12 Step 4: Pipe length = 40

CULVERT PROFILE & CROSS SECTION

(BBR Manual – pg. 20)

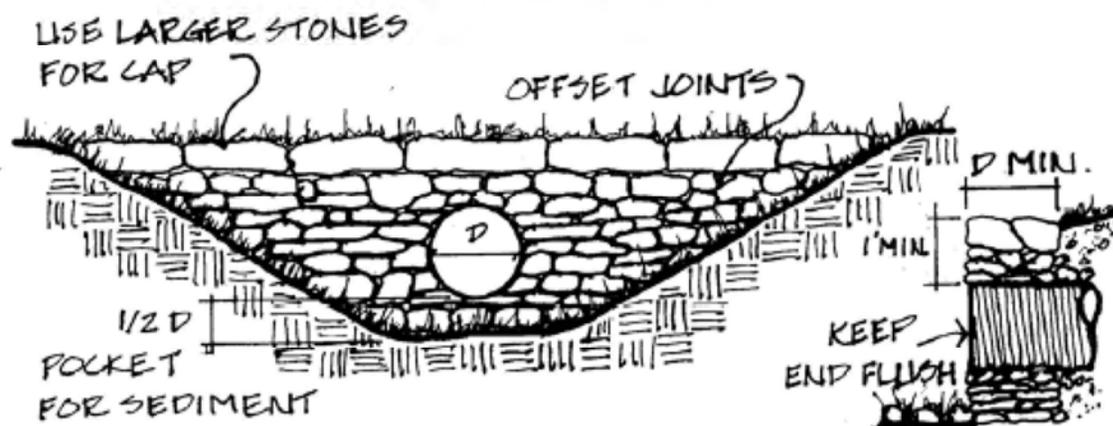
HEADER

(BBR Manual – pg. 24)

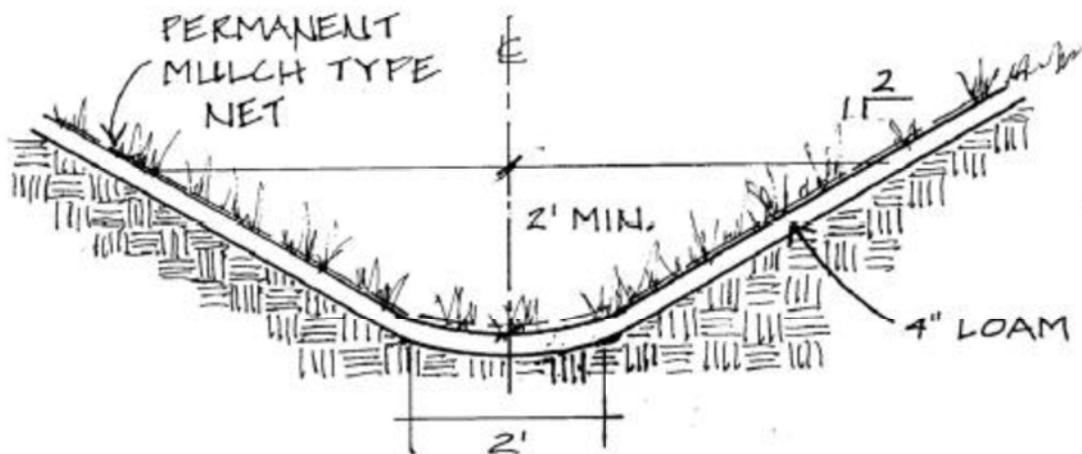
GRASS LINED DITCH

(BBR Manual – pg. 12)

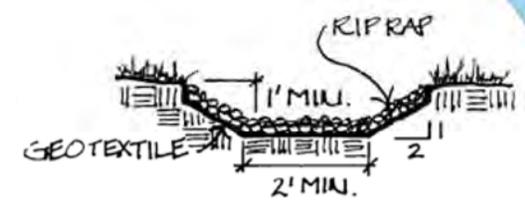
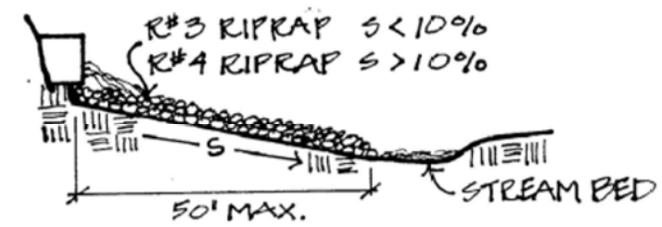
RIPRAP CONVEYANCE CHANNEL

(BBR Manual – pg. 30)

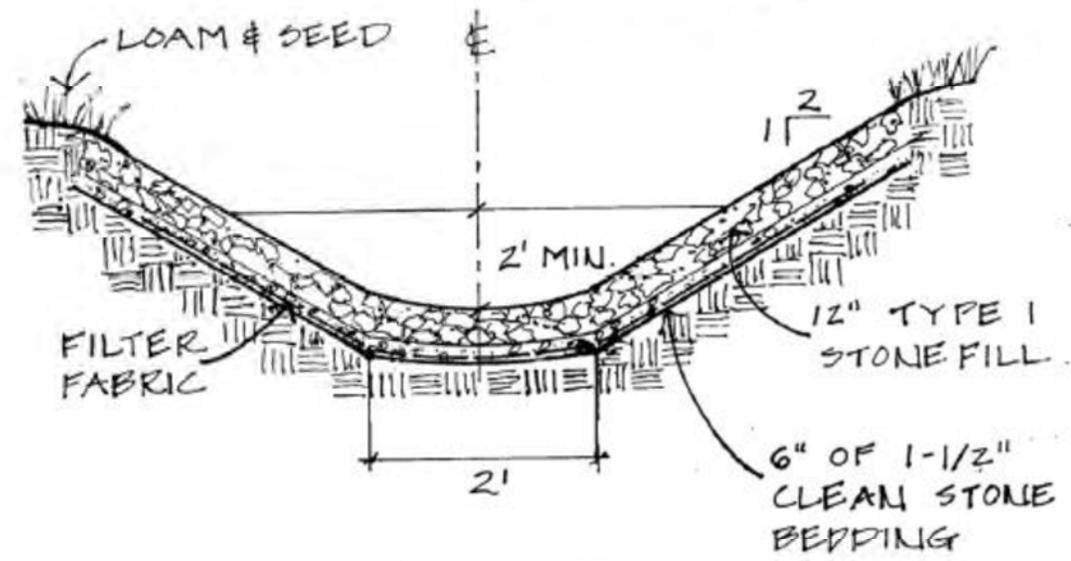
TABLE 1: DITCH LININGS		
Channel Slope	Lining	Thickness
0-5%	grass	
5-10%	R#3 (2 - 6 inch) diameter rock	7.5"
> 10%	R#4 (3-12 inch) diameter rock	12"

STONE LINED DITCH

(BBR Manual – pg. 13)

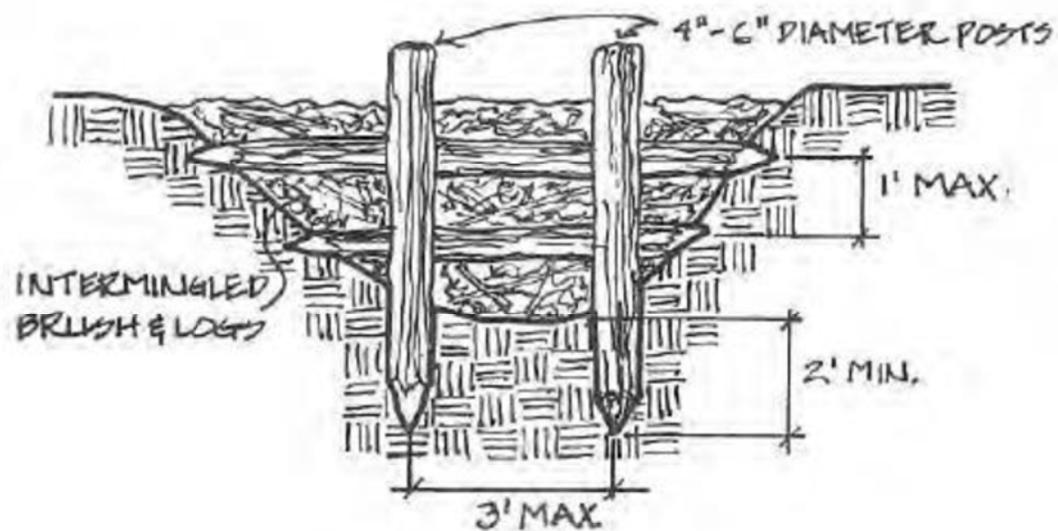
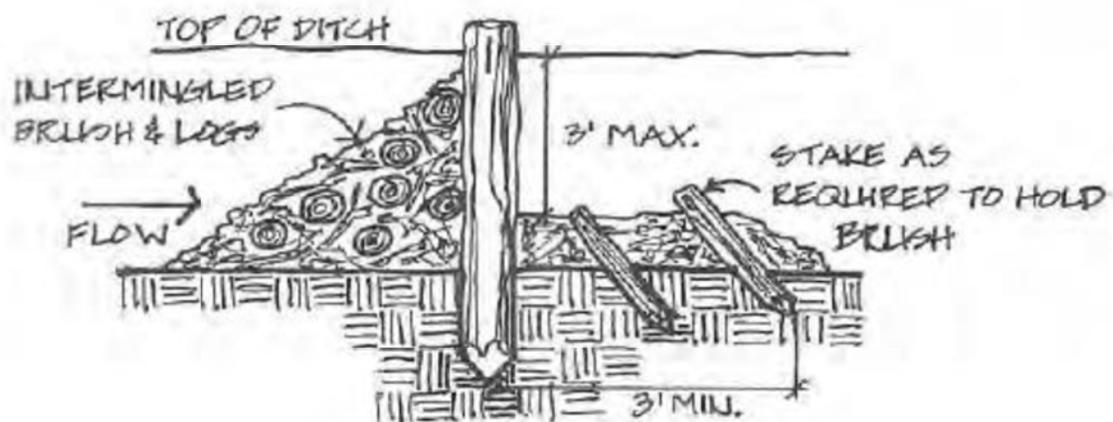
LOG & BRUSH CHECK DAMS

(BBR Manual – pg. 18)

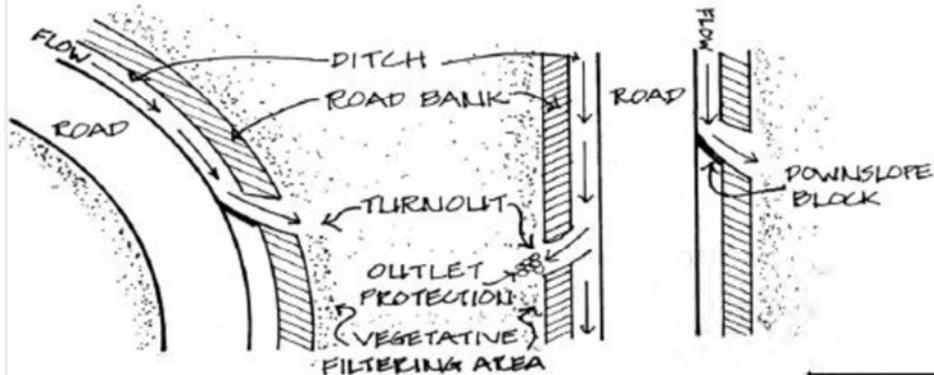
TURNOUTS
(BBR Manual – pg. 28)

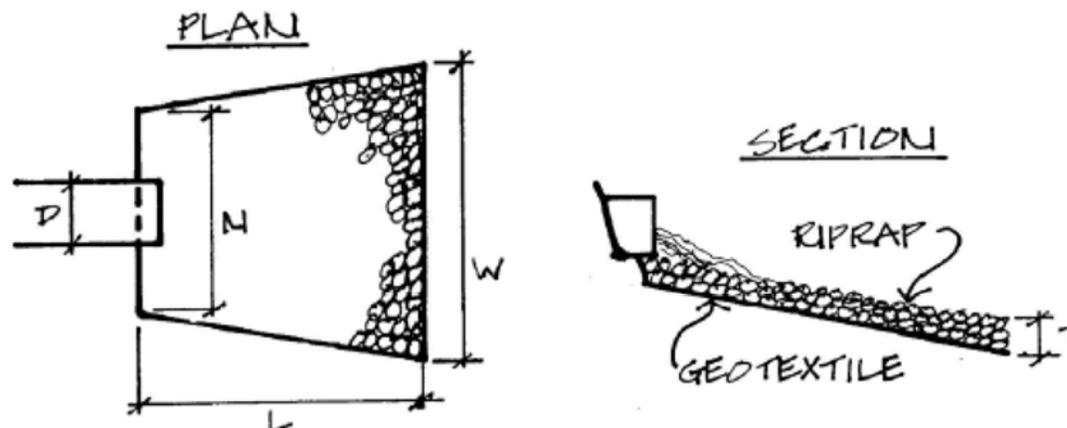
Rock Apron Specifications					
Culvert Diameter (D)	Riprap Size	T (in.)	N (ft.)	W (ft.)	L (ft.)
18 inches	(3-12 inch)	18	4.5	14.5	10.0
24 inches	(3-12 inch)	18	6.0	20.0	14.0

D= diameter of culvert
 T= depth of stone in apron
 N= width of apron near culvert
 W= width at downhill end of apron
 L= length of apron

ROCK APRON
(BBR Manual – pg. 29)

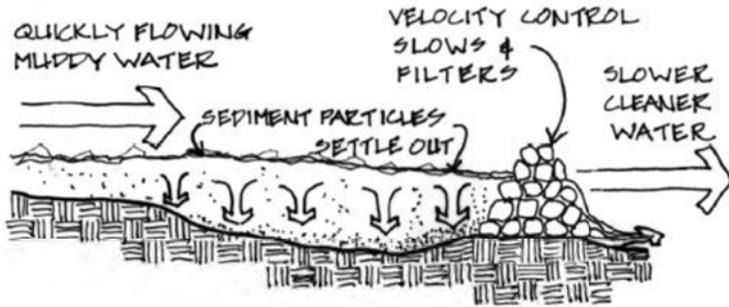
VELOCITY CONTROL
 (BBR Manual – pg. 16)

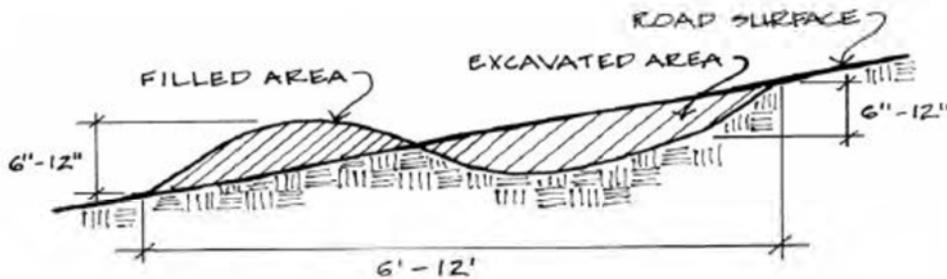
WATERBAR CROSS-SECTION
 (BBR Manual – pg. 51)

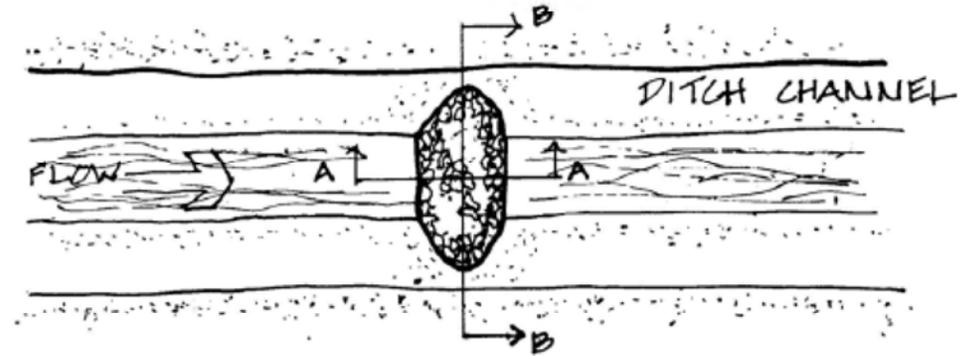
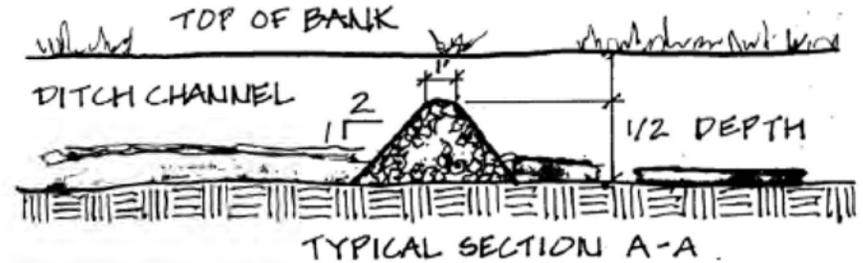
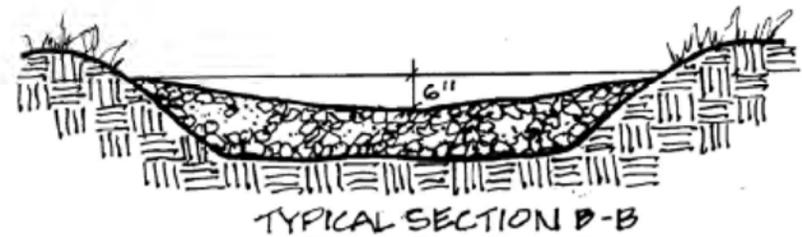
STONE CHECK DAMS
 (BBR Manual – pg. 17)

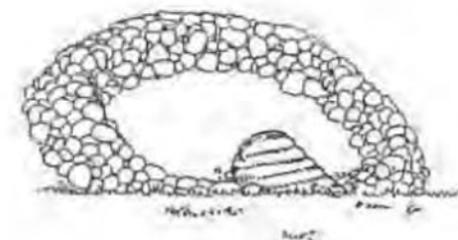
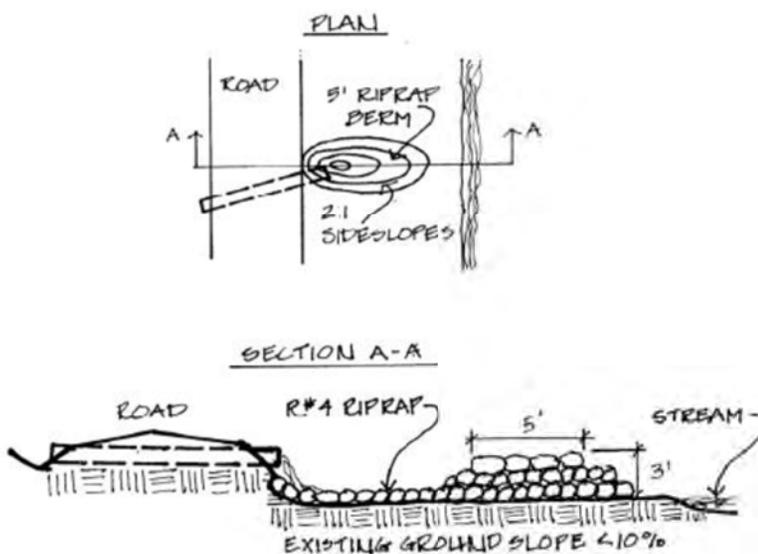
SPLASH/PLUNGE POOL

Riprap basin located at outlet of a culvert pipe.

- Used to remove sediments (by absorbing energy from flowing water and allowing sediments to settle out) from areas with concentrated flows and areas without adequate vegetative filter strips.
- Limited to areas with less than 10% slope.
- Consolidates sediment for easier removal.
- Reduces energy and velocity of flows by providing storage of runoff.
- Can allow for ground water recharge.
- Clean when pool area is one third filled with sediment.
- Locate the pool so that mechanized cleaning is possible.
- See pool capacity requirements chart on next page for sizing.

Distance Between Culverts (ft.)	Pool Capacity (cu. ft.)	
	Crowned road	Banked road
500	230	460
400	180	360
350	160	320
300	140	280
250	120	240
200	100	200

TYPE I STONE FILL
 (VAOT SEC. 706.04(A))
 THE LONGEST DIMENSION OF THE STONE SHALL VARY FROM 1 INCH TO 12 INCHES, AND AT LEAST 50 PERCENT OF THE VOLUME OF THE STONE IN PLACE SHALL HAVE A LEAST DIMENSION OF 4 INCHES.

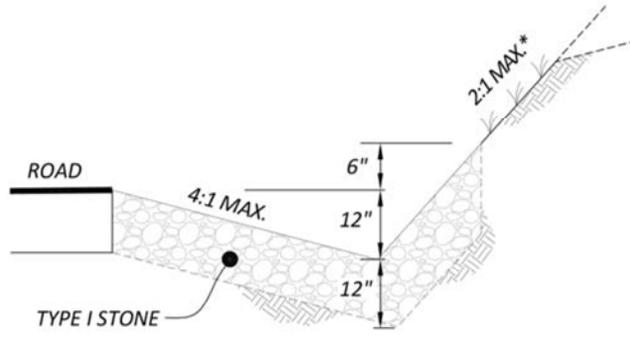
SECTION VIEW

* IF EXISTING SIDE SLOPES ARE STEEPER THAN 2:1, BUT STABLE, DO NOT REGRADE SLOPE.
 IF THERE IS INSUFFICIENT WIDTH FOR 2:1 SIDE SLOPES, USE A STEEPER SLOPE ON THE BACKSIDE OF THE SWALE, AWAY FROM THE ROAD, AND STABILIZE WITH NORTH AMERICAN GREEN S150 EROSION BLANKET (SEE DETAIL B).
 IF STEE SLOPE IS SATURATED WITH GROUNDWATER, FACE WITH 2-4" DIA. CRUSHED STONE AT LEAST 6" DEEP.

NOTE:
 USE DETAIL A WHEN STABILIZED ROADSIDE SWALE IS "SQUEEZED" BETWEEN ROAD AND STEEP SIDE SLOPE. INTENT IS THAT VEHICLES CAN RUN ONTO ADJACENT 4:1 SLOPE IN EMERGENCY.

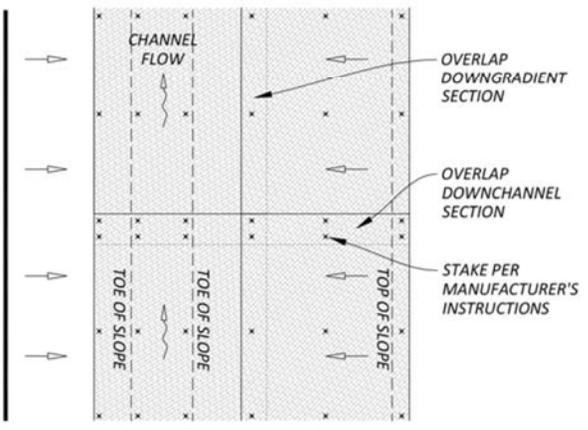
PLAN VIEW

DETAIL B VEGETATIVE CHANNEL STABILIZATION WITH AND WITHOUT EROSION BLANKET

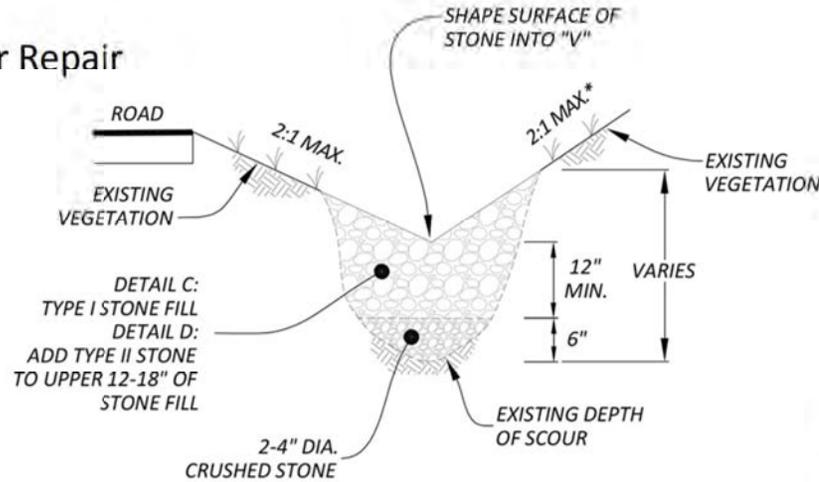
**DETAIL C/D
SWALE SCOUR REPAIR**

VTrans Detail Name: Ditch Scour Repair

TYPE I STONE FILL
(VAOT SEC. 706.04(A))
THE LONGEST DIMENSION OF THE STONE SHALL VARY FROM 1 INCH TO 12 INCHES, AND AT LEAST 50 PERCENT OF THE VOLUME OF THE STONE IN PLACE SHALL HAVE A LEAST DIMENSION OF 4 INCHES.

TYPE II STONE FILL
(VAOT SEC. 706.04(A))
THE LONGEST DIMENSION OF THE STONE SHALL VARY FROM 2 INCHES TO 36 INCHES, AND AT LEAST 50 PERCENT OF THE VOLUME OF THE STONE IN PLACE SHALL HAVE A LEAST DIMENSION OF 12 INCHES.

* IF EXISTING SIDE SLOPES ARE STEEPER THAN 2:1, BUT STABLE, DO NOT REGRADE SLOPE. IF THERE IS INSUFFICIENT WIDTH FOR 2:1 SIDE SLOPES, USE A STEEPER SLOPE ON THE BACKSIDE OF THE SWALE, AWAY FROM THE ROAD, AND STABILIZE WITH NORTH AMERICAN GREEN S150 EROSION BLANKET (SEE DETAIL B).

1. USE DETAIL C/D TO REPAIR EXISTING GRASS SWALES WITH ACTIVE CUTTING.
2. USE DETAIL C WITH ONLY TYPE I STONE FOR SWALES WITH SLOWER FLOW VELOCITIES.
3. USE DETAIL D WITH TYPE II STONE FOR SWALES WITH HIGHER FLOW VELOCITIES.

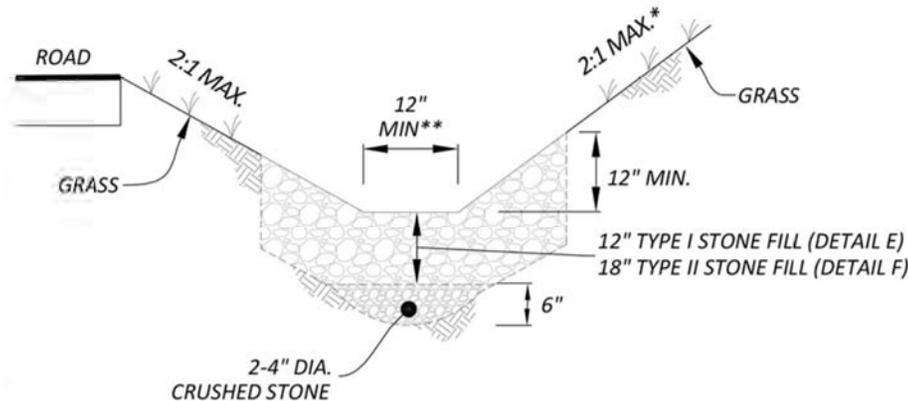
**DETAIL E/F
STONE SWALE**

* IF >2:1, INSTALL NORTH AMERICAN GREEN S150 PER MANUFACTURER'S INSTRUCTIONS, BOTTOM AND STEEP SIDE OF CHANNEL (SEE DETAIL B)

** SHAPE STONE SURFACE AS "V" IF SPACE FOR SWALE IS TOO NARROW FOR FLAT SURFACE
