Town of Hyde Park Road Erosion Inventory Report

Lamoille County Planning Commission

December 2017

Inventory and report funded by the Vermont Agency of Transportation 2016 Better Roads Program

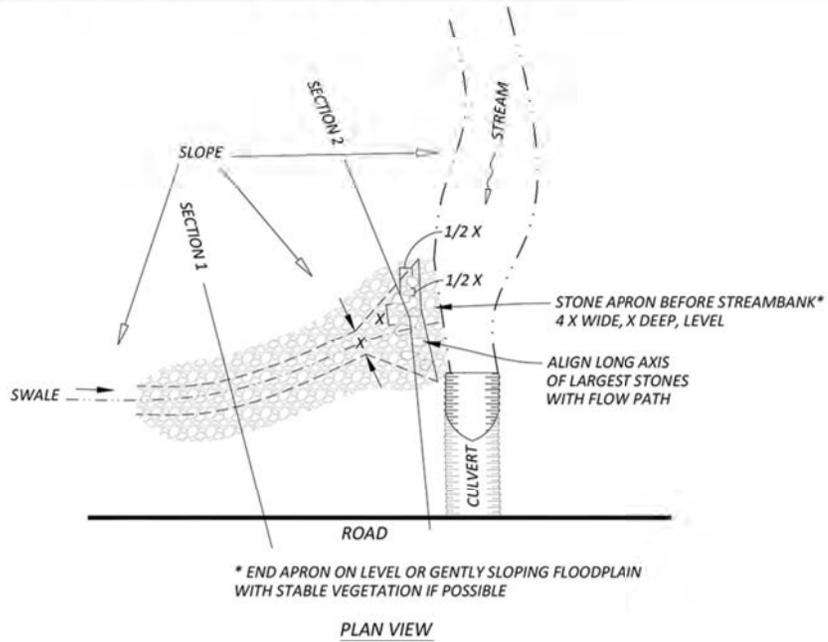
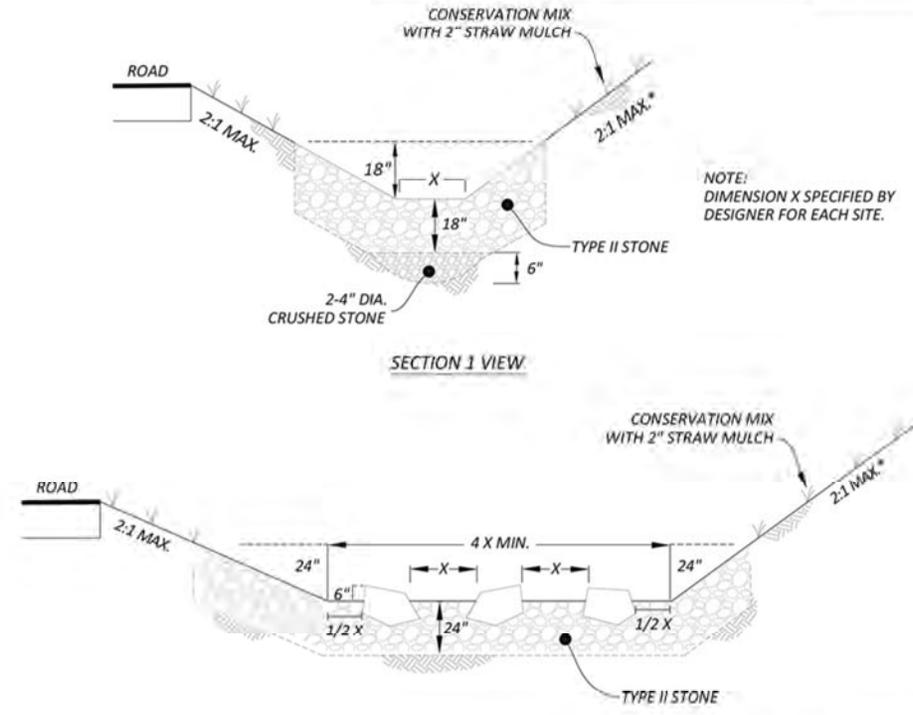
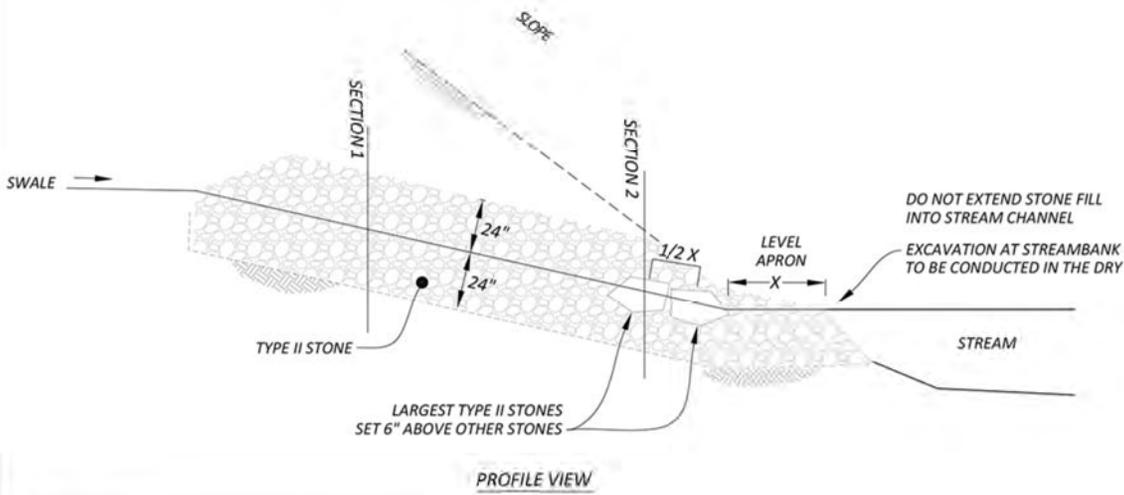
DETAIL G
STONE CHUTE AND SPREADER

NOTE:
DIMENSION X SPECIFIED BY
DESIGNER FOR EACH SITE.

* IF EXISTING SIDE SLOPES ARE STEEPER THAN 2:1, BUT STABLE, DO NOT REGRADE SLOPE. IF THERE IS INSUFFICIENT WIDTH FOR 2:1 SIDE SLOPES, USE A STEEPER SLOPE ON THE BACKSIDE OF THE SWALE, AWAY FROM THE ROAD, AND STABILIZE WITH NORTH AMERICAN GREEN SLSO EROSION BLANKET (SEE DETAIL B).

TYPE II STONE FILL (VAOT SEC. 706.04(A))
THE LONGEST DIMENSION OF THE STONE SHALL VARY FROM 2 INCHES TO 36 INCHES, AND AT LEAST 50 PERCENT OF THE VOLUME OF THE STONE IN PLACE SHALL HAVE A LEAST DIMENSION OF 12 INCHES.

NOTE:
USE DETAIL G ALONG STEEPER SWALES, TYPICALLY DISCHARGING TO STREAMS OR FLOODPLAINS. IF STREAMBANK IS UNSTABLE AND ERODING, CONDUCT MORE DETAILED ENGINEERING STUDY BEFORE USING DETAIL G.

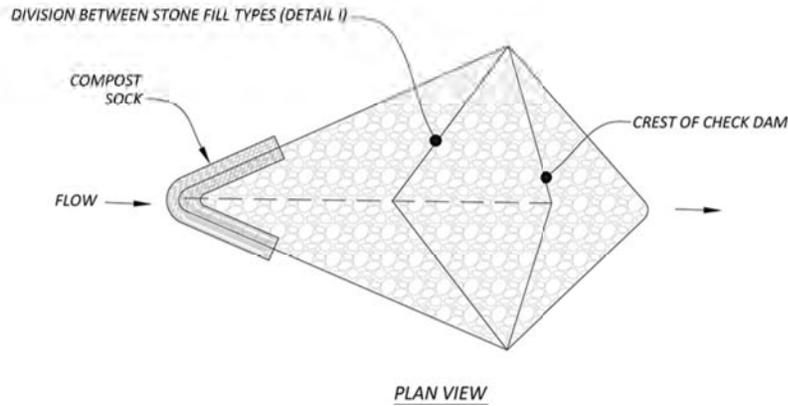
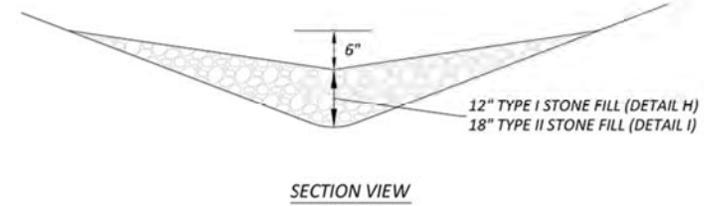
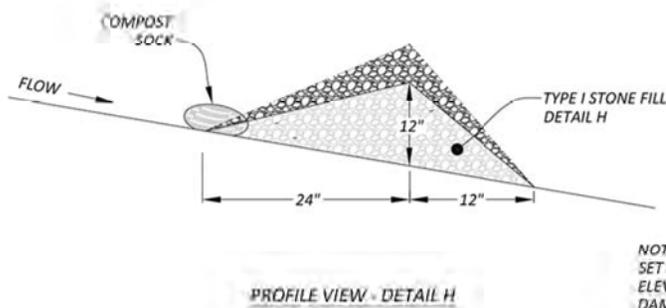
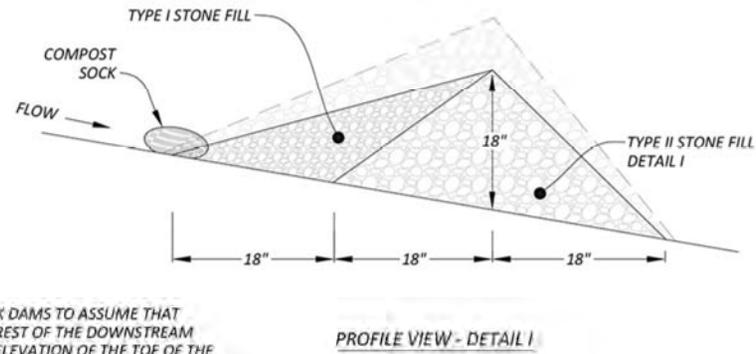
DETAIL H/I
STONE CHECK DAM
NTS

NOTE:
SET SPACING OF CHECK DAMS TO ASSUME THAT ELEVATIONS OF THE CREST OF THE DOWNSTREAM DAM IS AT THE SAME ELEVATION OF THE TOE OF THE UPSTREAM DAM"

TYPE I STONE FILL
(VAOT SEC. 706.04(A))
THE LONGEST DIMENSION OF THE STONE SHALL VARY FROM 1 INCH TO 12 INCHES, AND AT LEAST 50 PERCENT OF THE VOLUME OF THE STONE IN PLACE SHALL HAVE A LEAST DIMENSION OF 4 INCHES.

TYPE II STONE FILL
(VAOT SEC. 706.04(A))
THE LONGEST DIMENSION OF THE STONE SHALL VARY FROM 2 INCHES TO 36 INCHES, AND AT LEAST 50 PERCENT OF THE VOLUME OF THE STONE IN PLACE SHALL HAVE A LEAST DIMENSION OF 12 INCHES.

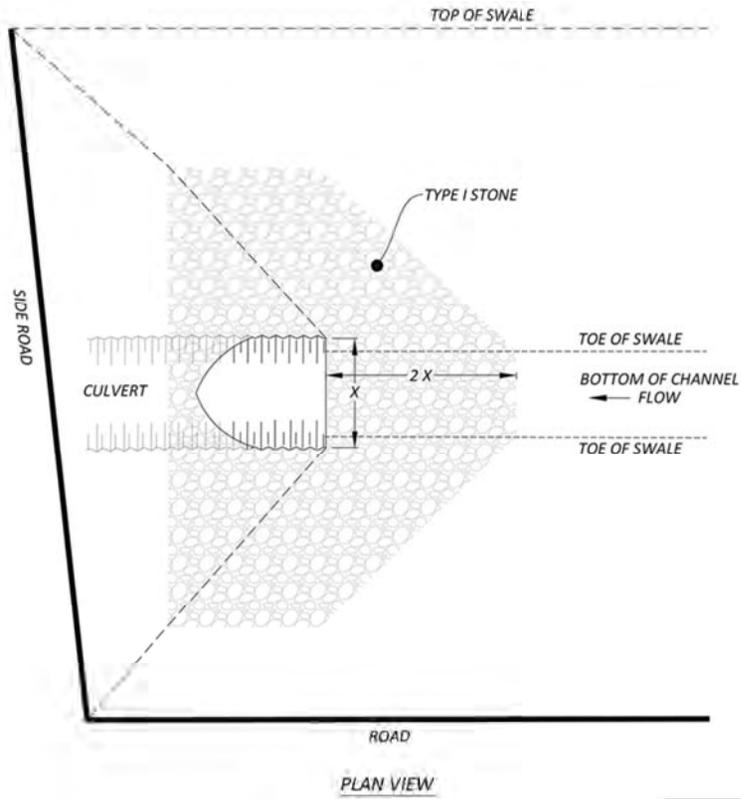
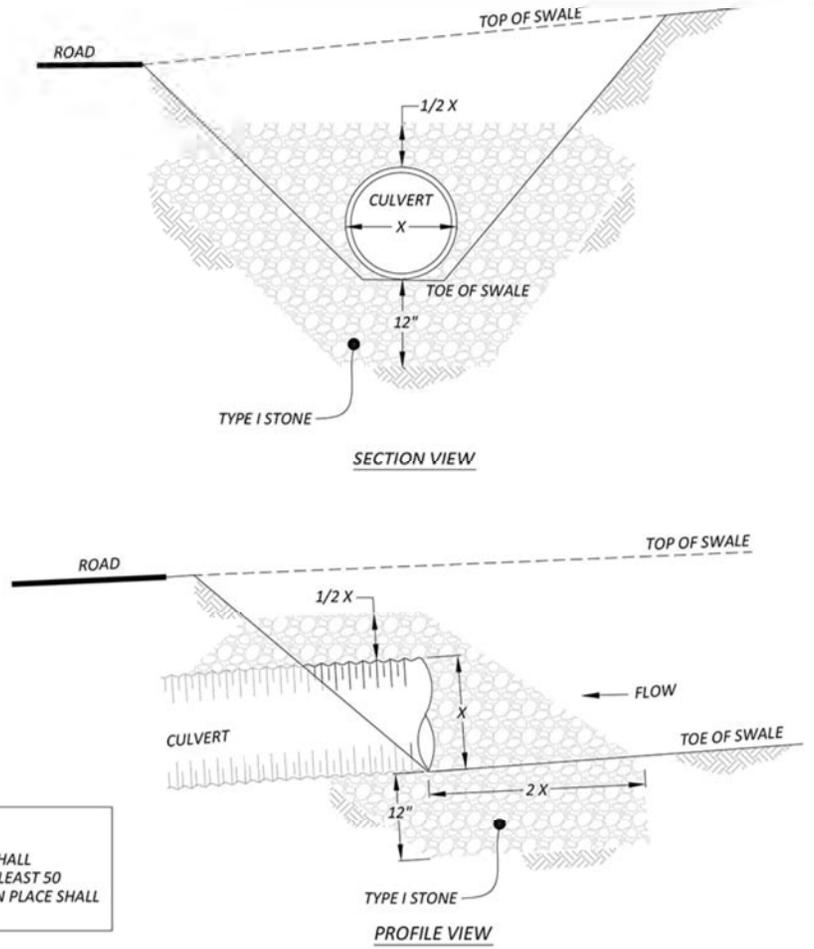
DETAIL J
CULVERT ENTRANCE STABILIZATION

TYPE I STONE FILL
 (VAOT SEC. 706.04(A))
 THE LONGEST DIMENSION OF THE STONE SHALL VARY FROM 1 INCH TO 12 INCHES, AND AT LEAST 50 PERCENT OF THE VOLUME OF THE STONE IN PLACE SHALL HAVE A LEAST DIMENSION OF 4 INCHES.

NOTE:
 USE DETAIL J IN LIEU OF CULVERT HEADWALL WHERE ENTERING FLOW IS SCOURING BOTTOM AND SIDES OF SWALE

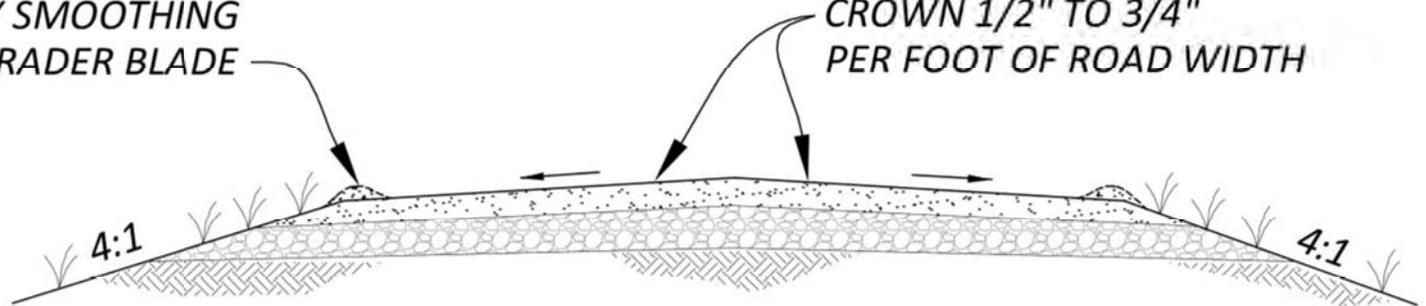
DETAIL L

WINTER SAND BUILD-UP AND
SAND FROM GRADER TO BE
ELIMINATED BY SMOOTHING
EDGE OF ROAD WITH GRADER BLADE

CROWN 1/2" TO 3/4"
PER FOOT OF ROAD WIDTH

TYPICAL ROAD CROWN SECTION
